## Lining Chimneys for Solid Fuel Appliances

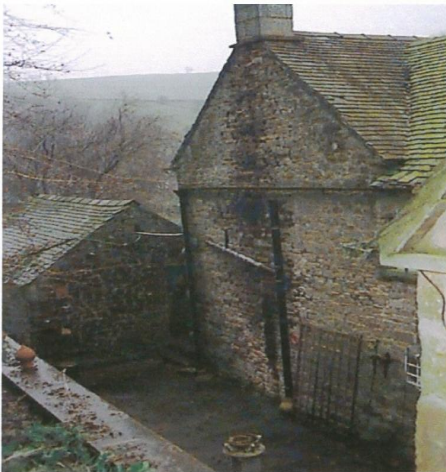
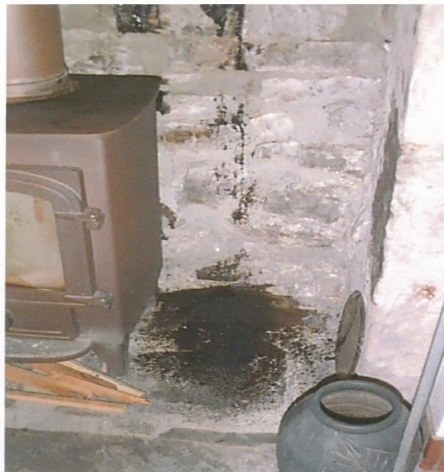
These pictures are of a property where the installer decided that the chimney was in good condition.

Unfortunately for the customer the condensates have soaked through the walls.

The gable end of the property will require rebuilding and all of the contaminated stone work will need replacing, the chimney will then need to be lined.
